# Manhole Inspection Summary

Manhole # S25EE1021MH

Insp Date: **1/25/07 9:26 AM**

**Location** Address: **1203 MORLING AVE**

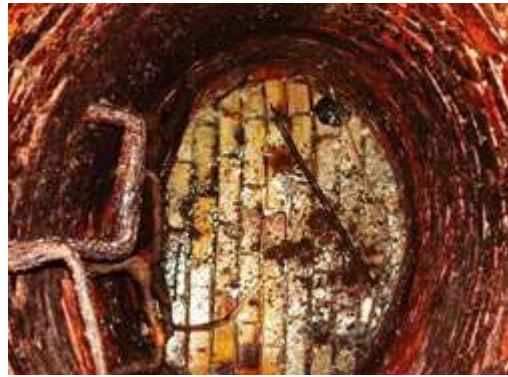
Top View

Corroded and missing steps. Channel debris.

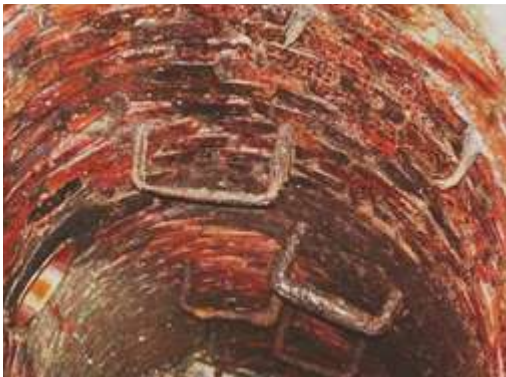
Defect

Adjustment , Corbel, and Barrel infiltration.

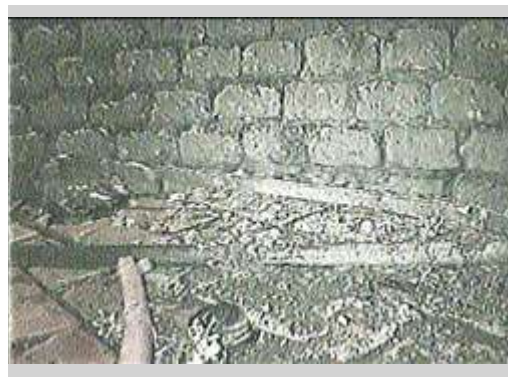
Defect

Barrel deterioration and infiltration.

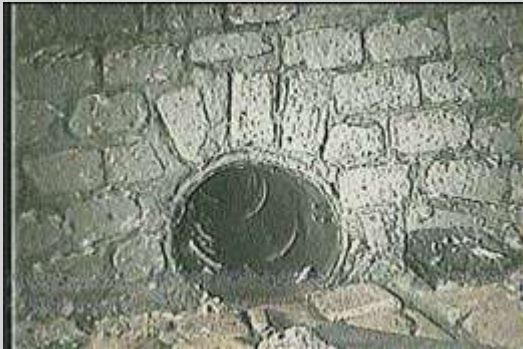
### 8 in. Circular Gravity Sewer Pipe Out @ 12 O'Clock

Infiltration: **Evidence** Pipe Seal Cond: **Cracked**
